**OFFICE OF FISHERIES
INLAND FISHERIES SECTION
PART VI-A
WATERBODY MANAGEMENT PLAN SERIES**

LAKE BISTINEAU

LAKE HISTORY & MANAGEMENT ISSUES

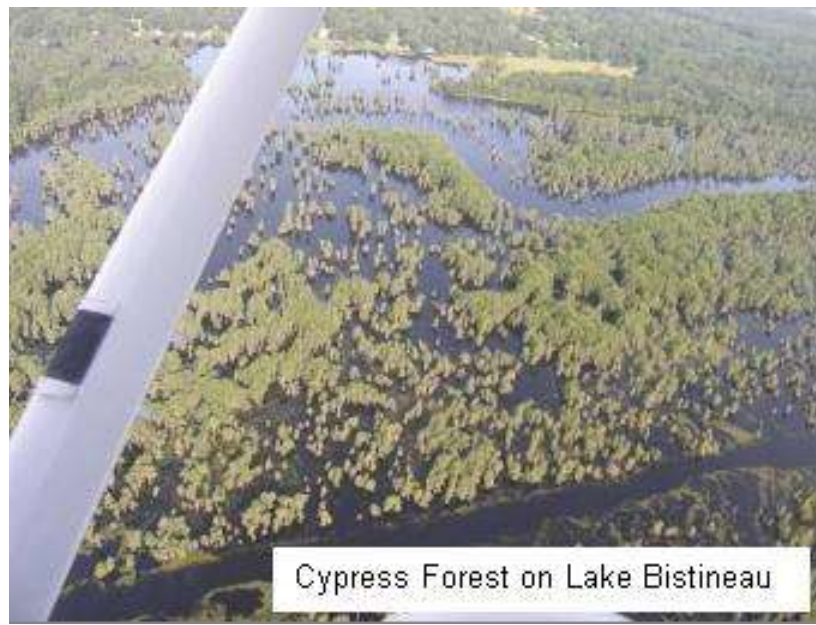
Figure 1. Aerial view showing cypress timber in Lake Bistineau.

Lake Bistineau is heavily forested with dense stands of cypress trees covering roughly half of the 17,200 surface acres of the lake (Figure 1). There are a few areas with large expanses of open water over 250 acres, these include Crane Lake, New Orleans Pond, Greg Lake and Catfish Pond. The other open water areas are generally much smaller slough channels through the cypress forest or the

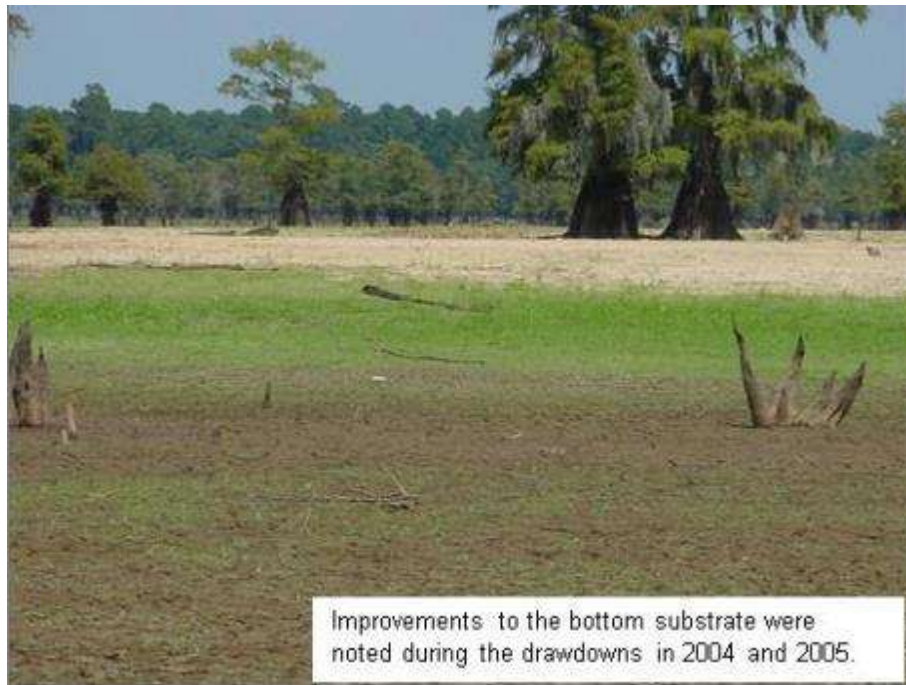
Figure 3. Lake Bistineau while undergoing a drawdown to dry out and oxidize organic matter to improve bottom firmness.

Previous drawdowns had demonstrated that a fall-winter drawdown in a typical year does not provide sufficient drying action to allow for substantial aerobic decomposition of organic material (Figure 3). In order to provide for effective drying of the lake bed, a July 15 start date was selected for the drawdowns. The lake was dewatered to the maximum extent possible (7 feet) with the current drawdown structure. The drawdown continued through the end of January when the gates were closed and the lake allowed refilling.

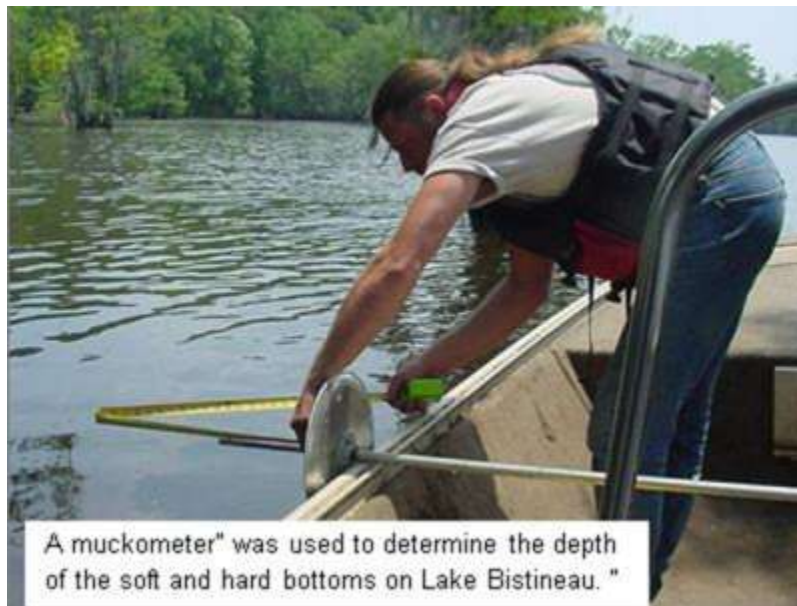
Figure 4. Measuring the depths of bottom organic muds in Lake Bistineau.

Two methods were utilized to quantify the reduction in organic material. One method involved the use of an improvised device termed the “muckometer” (Figure 4). This device was used to differentiate between the soft and hard bottoms of the lake while the lake was at normal levels. A 12” diameter perforated aluminum disk was mounted on a length of pipe which served as a sleeve for a ½” metal rod which slid down to identify the hard bottom. This device was placed vertically in the water until the perforated disk contacted the soft bottom of the lake. The weight of the apparatus defined the depth of the soft bottom. A set screw was then loosened allow the ½” metal rod to slide freely within the sleeve. A pressure scale was then used to apply 10 lbs. of pressure to the top of the metal rod to force the rod through the soft organic material on the lake bed and stop at the hard bottom of the lake. The set screw was then tightened and physical measurement made of the length the rod was protruding past the disk. This roughly equates to the depth of the organic material at the sample site. Three measurements were made at each station.

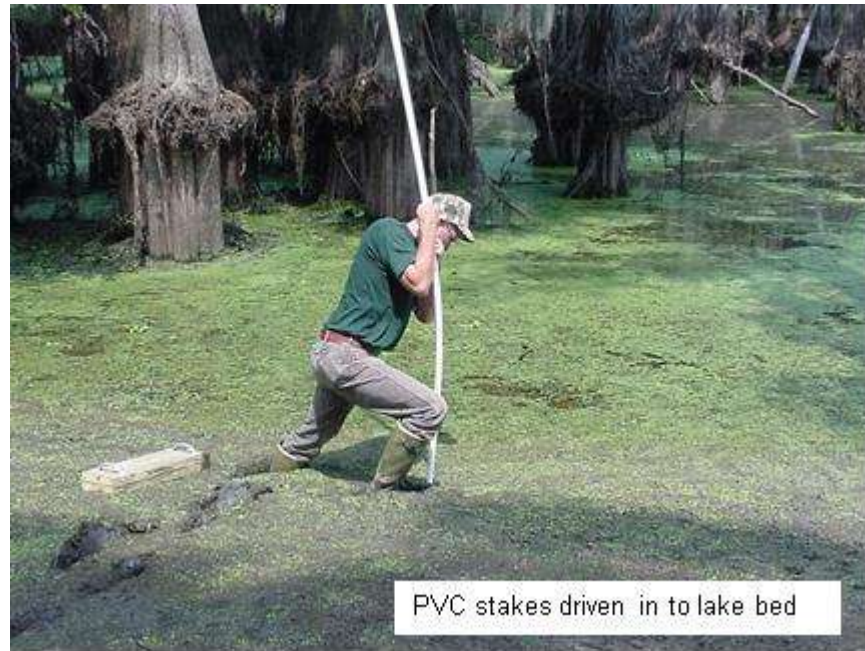
Figure 5. Inserting PVC stakes into the lake bottom.

The other method consisted of placing ¾” PVC stakes in the lake bed during the initial dewatering process of the 2004 drawdown (Figure 5). Stakes were pushed into the lake bed and then hammered in further to the point of refusal of further penetration. The stakes were allowed to protrude 1.5” above the bottom substrate (Figure 6). After significant drying action occurred during the 2004 drawdown and in subsequent drawdowns, measurements of the height the stakes protruded above the bottom substrate were made (Figure7). The difference in the height the stakes protrude above the lake bed roughly equates to the reduction in organic material on the lake bed at the site. Both methods indicate a significant reduction in organic material following the drawdowns.

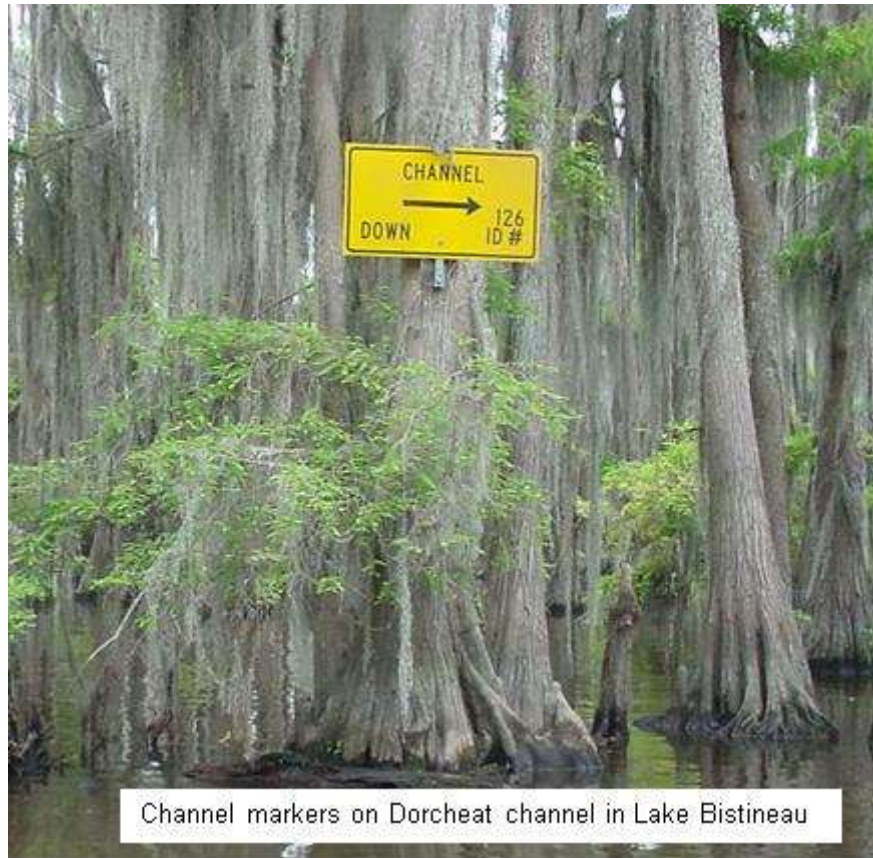
Figure 8. Channel markers fastened to cypress trees along the Bayou Dorcheat channel in Lake Bistineau.

New channel markers were installed in 1993 by the Department of Transportation and Development with assistance from the Louisiana Department of Wildlife and Fisheries. In most areas of the lake, the signs marking the channel were attached directly to the cypress trees (Figure 8). In areas that lacked sufficient cypress trees, the metal signs were placed on pilings adjacent to the Bayou Dorcheat channel. Many of these metal signs have been compromised by the effects of wind and have fallen into the lake. There currently is a need to remark the main channel of the lake, replace signs that are missing, and trim cypress limbs that obscure signs attached to trees.
